MEADOWSTONE ALPHA
SERIES, STAGE 4, WANAKA

GEOTECHNICAL COMPLETION REPORT & PROVISION OF SCHEDULE 2A
FOR MEADOWSTONE ALPHA SERIES, STAGE 4 (LOTS 65 - 84)

REF: R6783-4A
DATE: 05 MAY 2025

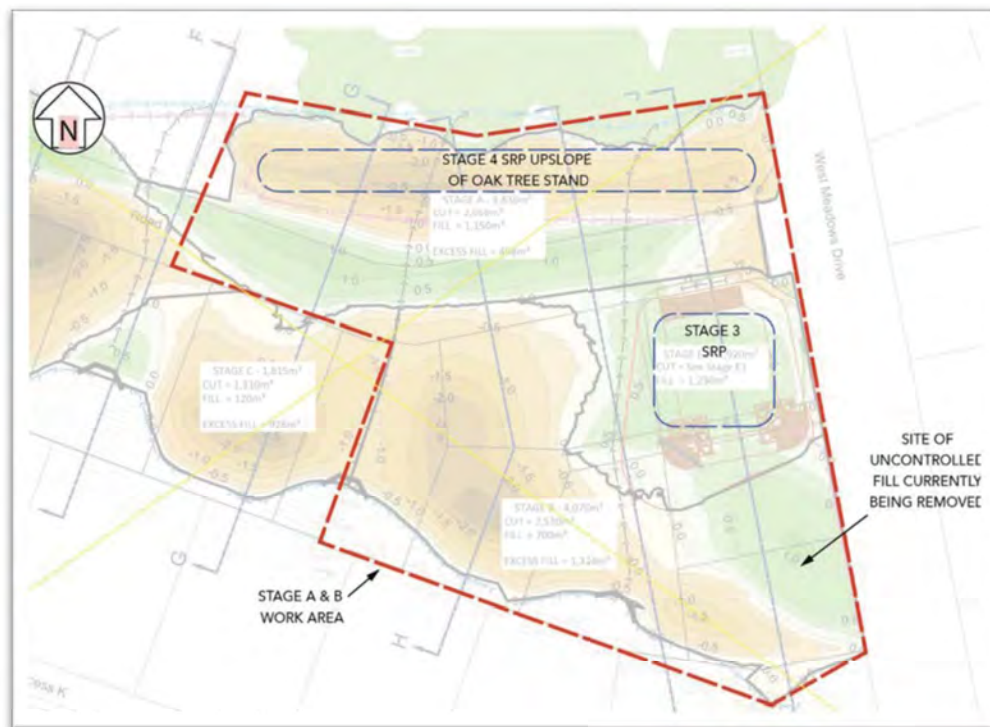
Sketch 1. Extent of earthworks as at 210330

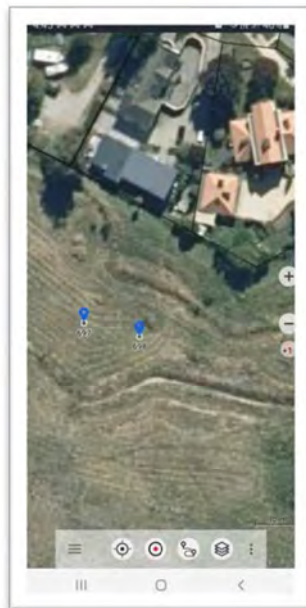
- A single SPT twinned each test pit. The SPT locations and test results are illustrated in the figure and table below respectively.

Figure 1: SPT locations. Waypoint 697 = TP101, Waypoint 698 = TP102

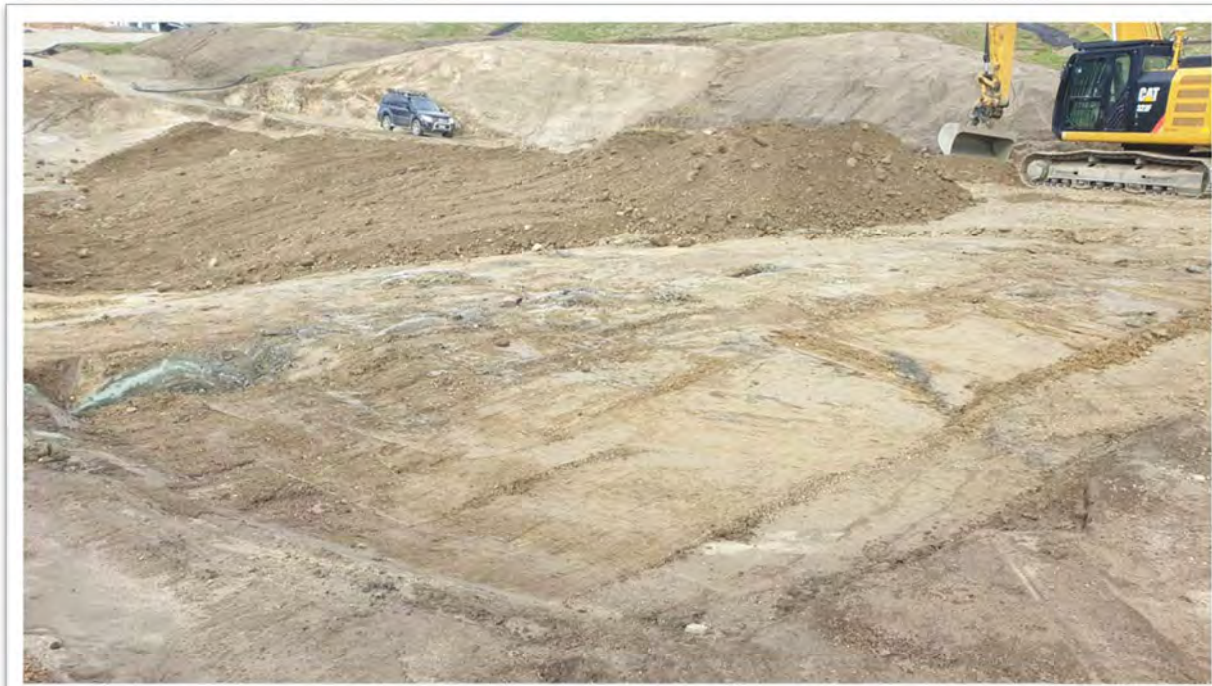
PHOTO 1 - SITE PHOTO LOOKING TOWARDS THE SOUTHEAST,
 LEFT: (AREA NO. 1) FIRST 600MM FILL CONSTRUCTED (~ 1.8MFL). CENTRE: 300MM LOOSE FILL LAYER OVER MAIN FILL
 AREA. RIGHT: IMPROVED SUBGRADE SURFACE.

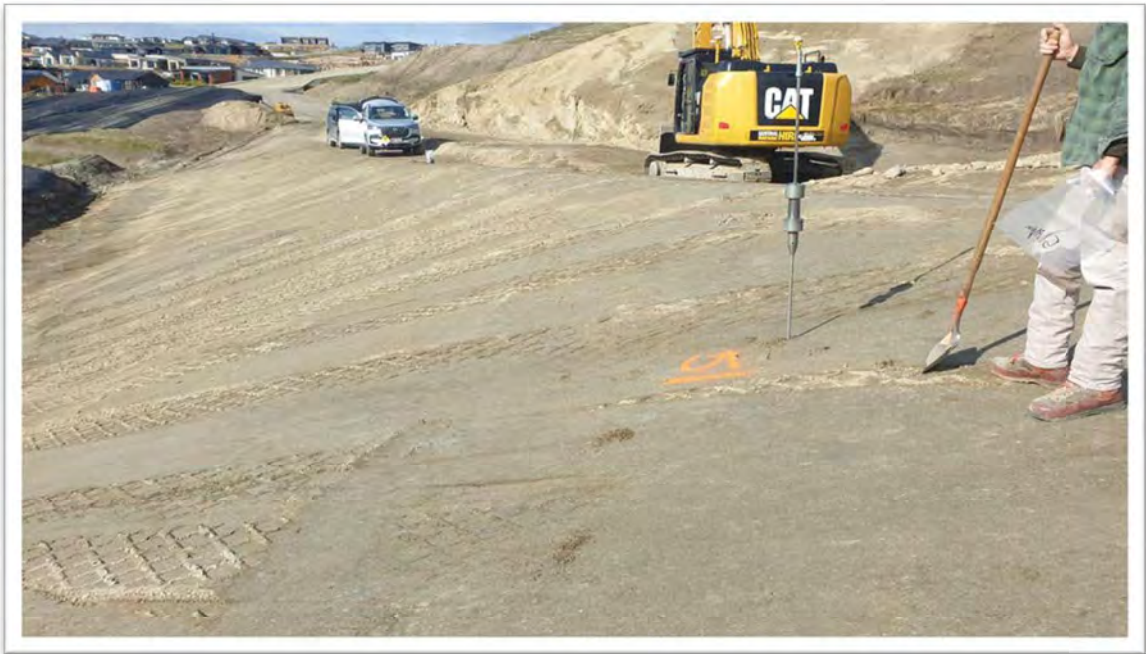
PHOTO 1 - SITE PHOTO LOOKING TOWARDS THE EAST, ILLUSTRATING A SINGLE FILL AREA OF THE -1.2MFL SUBBASE SURFACE, NDM NO. 51 IN THE FOREGROUND

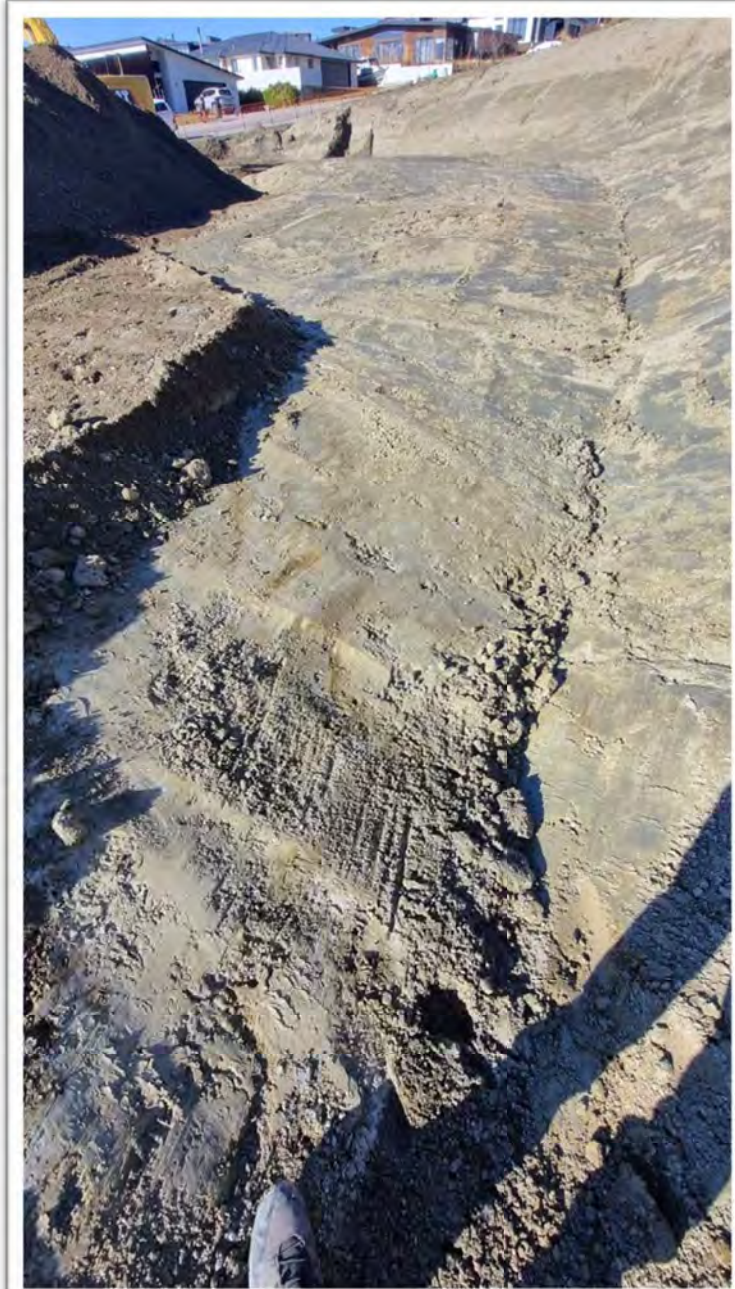
SITE PHOTO OF SUBGRADE IMPROVEMENT REQUIREMENT IN SOUTHEASTERN CORNER
